Name of Dam: Whites Dam

Location: Albemarle County, State of Virginia

Inventory Number: VA 00327

PHASE I INSPECTION REPORT NATIONAL DAM SAFETY PROGRAM

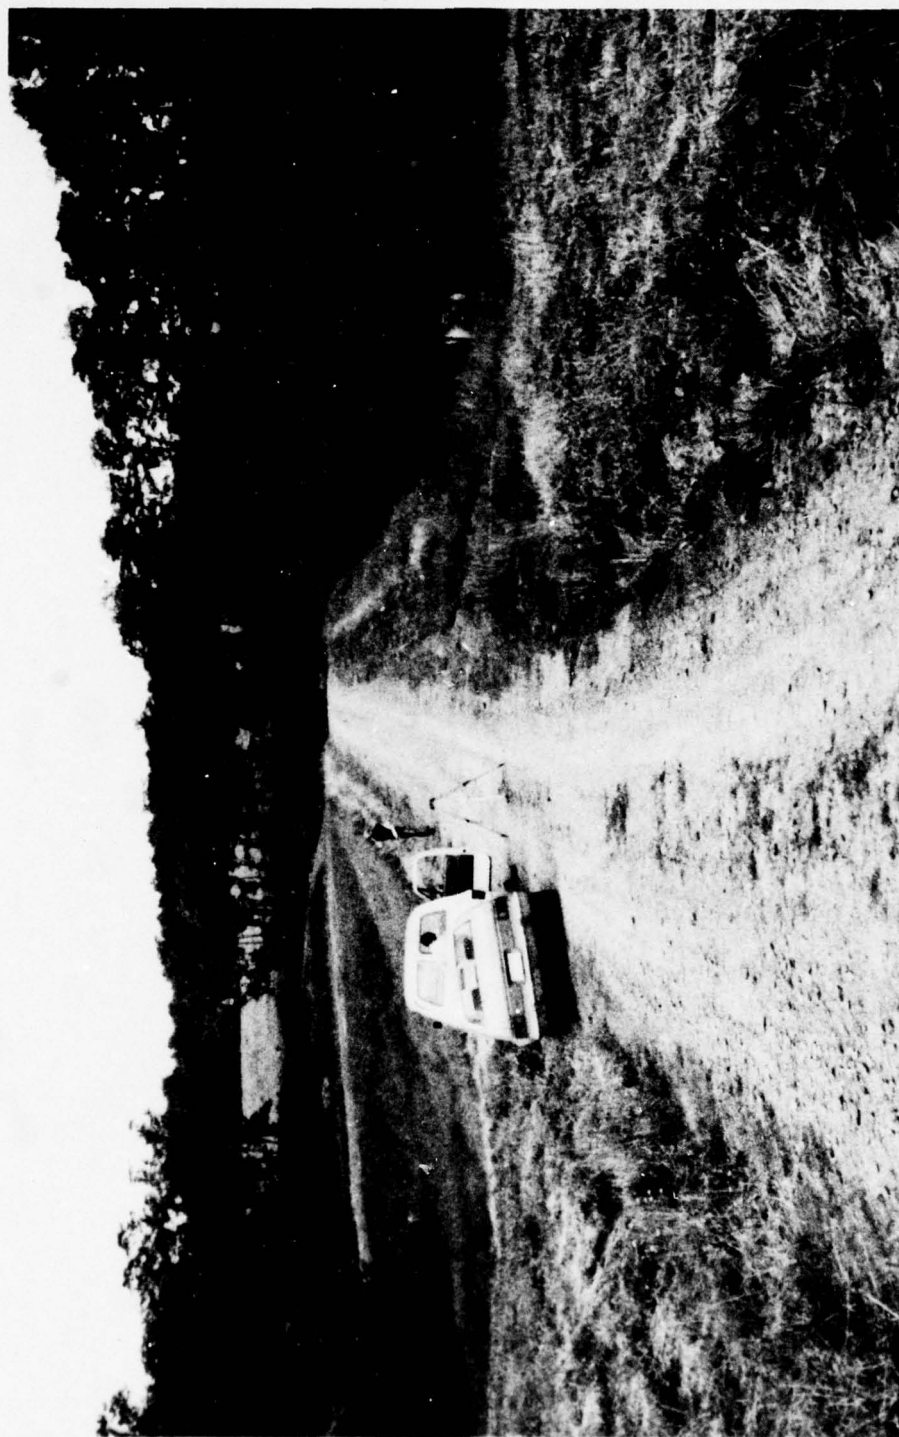
OVERALL VIEW OF DAM

The crest of the embankment is traversed for its full width by an earth roadway (see Overall View of Dam). Although not provided with an erosion resistant surface, no significant amounts of gulleying were noted.

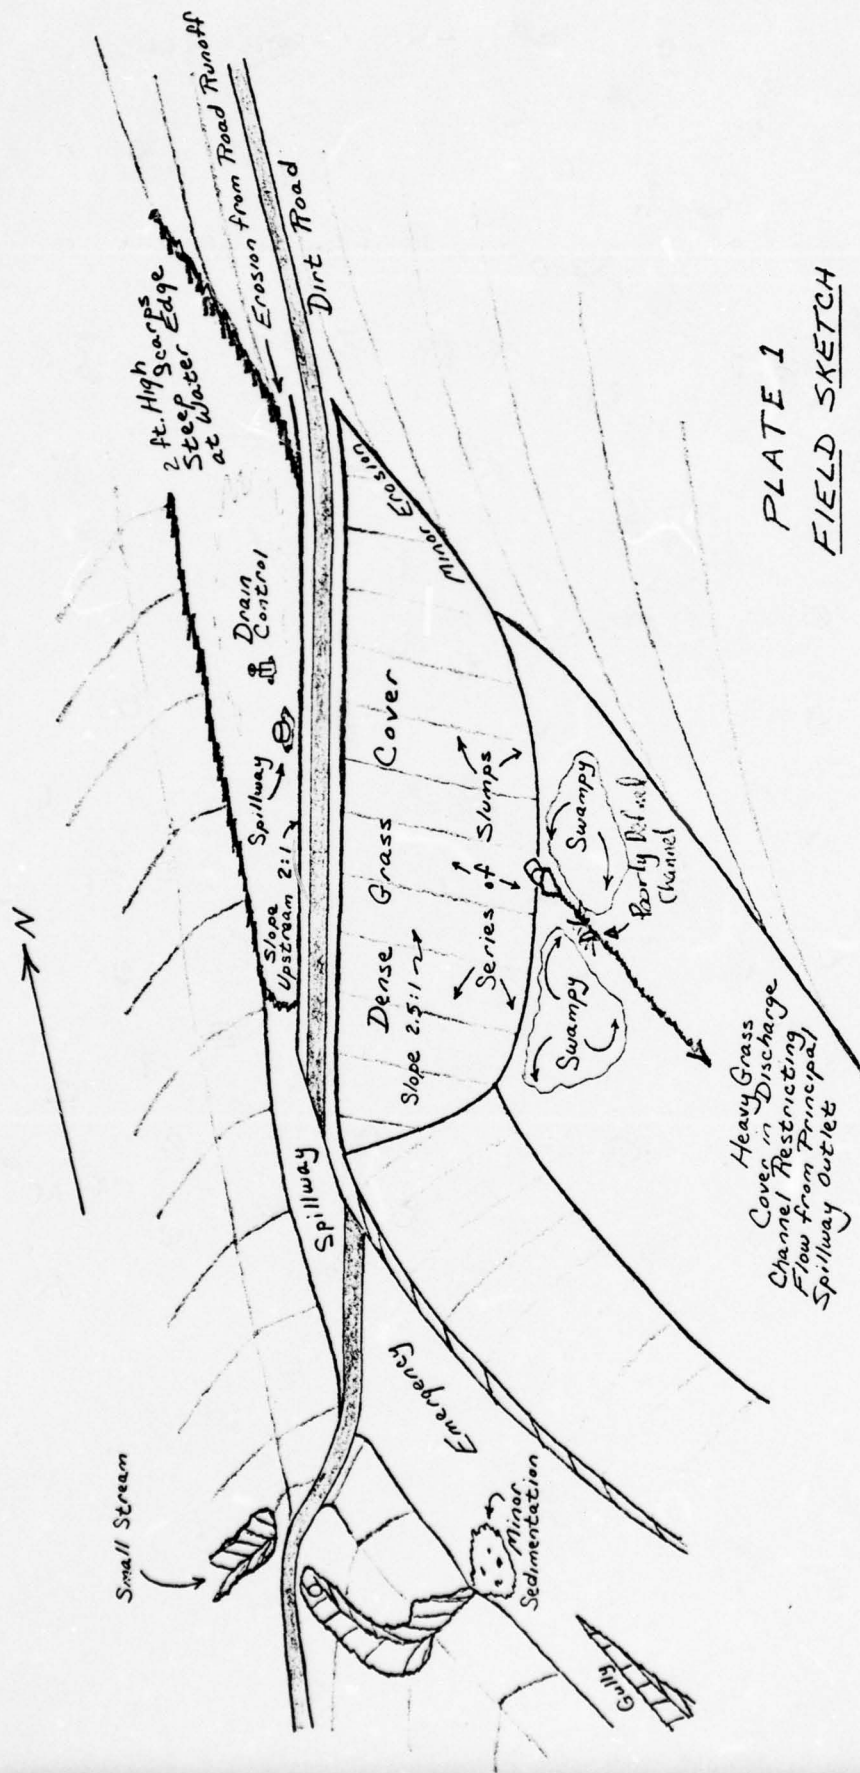
PLATE 1

Plate 1 is a Field Sketch of the dam which illustrates the conditions observed during the visual inspection. The complete visual inspection check list is included in Appendix III. Following are summaries of the deficiencies noted during the inspection.

- 3.1.2 Dam: Step-like slumping of the lower half of the downstream slope of the embankment (slope 2.5:1) has occurred at this facility (see Plate 1). Displacements of up to 2 feet along the more distinct slump scarps were noted. Each slump is less than 3 feet in width. The lower half of the slope is sparsely vegetated and the slumped areas are eroded (see Photo 5). The disturbed embankment material is firm and no seeps were detected in the slumped areas. The downstream toe area of the dam on either side of the outlet channel is very swampy, but no seepage was detected. Surface drainage is poor, probably due to the poor condition of the downstream channel, and the vegetation is thick (see Photo 3) in this area.

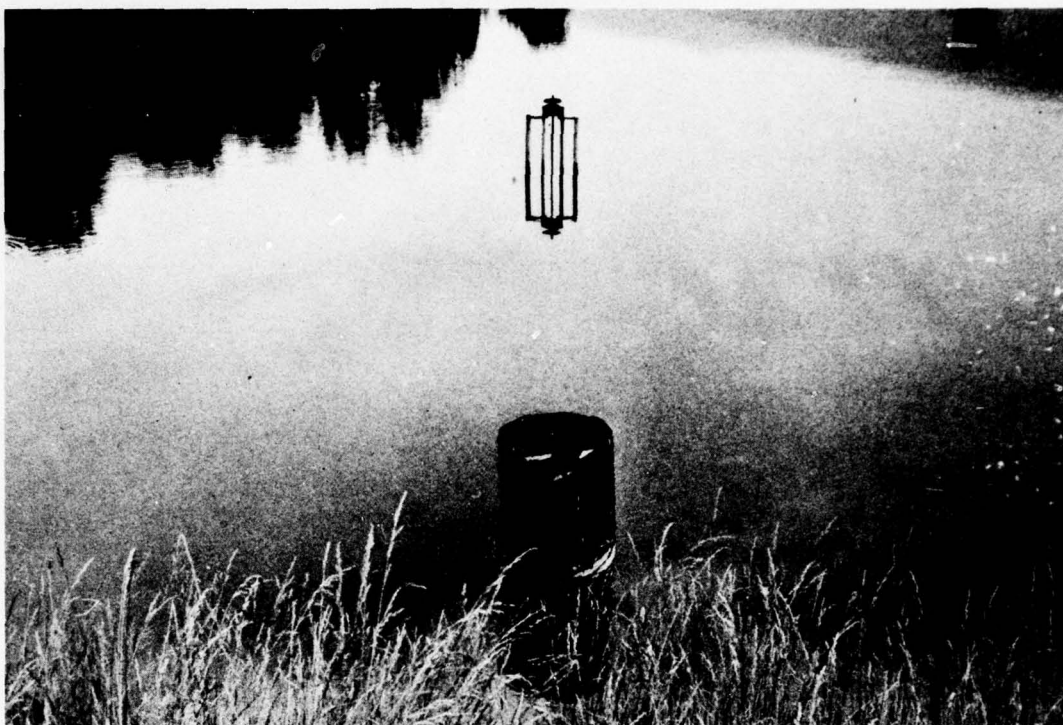
PHOTO 1. Principal Spillway Inlet and Drain Hand Crank

| VISUAL EXAMINATION OF | OBSERVATIONS | REMARKS OR RECOMMENDATIONS |
|---|---|--|
| INTAKE STRUCTURE | Some siltation around the riser intake was observed. No other problems were noted. | The sediment should be removed from around the intake to prevent blockage of the structure. |

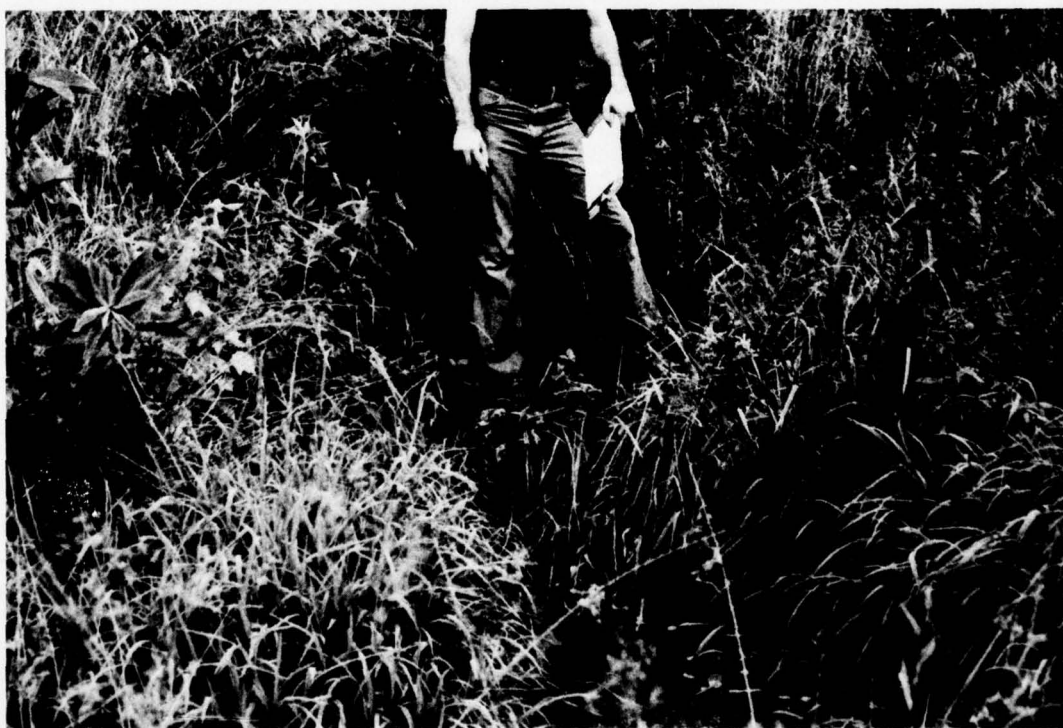
- 3.1.3 Appurtenant Structures: The principal spillway outlet is partially inundated due to restriction of flow in the discharge channel near the outlet. The discharge channel is heavily overgrown by high grass. A stilling basin is not provided and riprap is not present around the outlet to protect the toe of the dam (see Photo 2 and 3).

PHOTO 2. Principal Spillway Outlet and Restricted Discharge Channel

| VISUAL EXAMINATION OF | OBSERVATIONS | REMARKS OR RECOMMENDATIONS |
|---|---|--|
| OUTLET STRUCTURE | The outlet pipe is partially inundated due to the restricted condition of the outlet channel. | This condition is contributing to the swampy condition at the toe of the dam. |

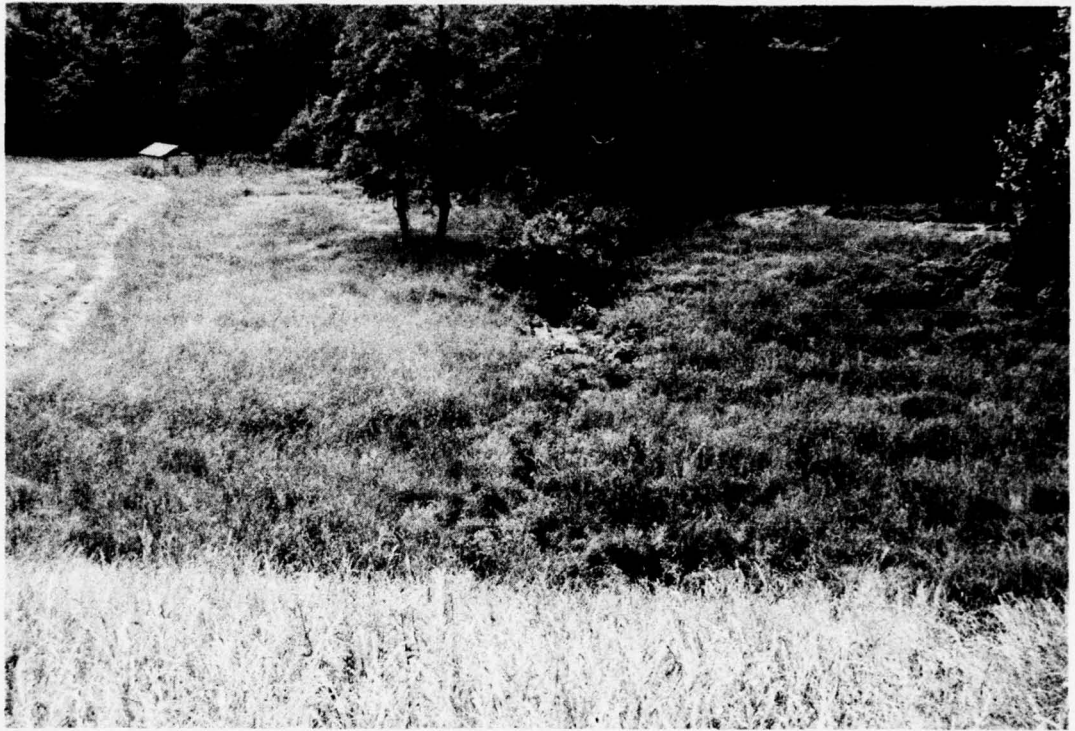
- 3.1.5 Downstream Channel: The downstream channel is overgrown by dense grass and drainage is poor, as explained in Sections 3.1.2 and 3.1.3.

PHOTO 3. View of Downstream Channel from Dam Crest

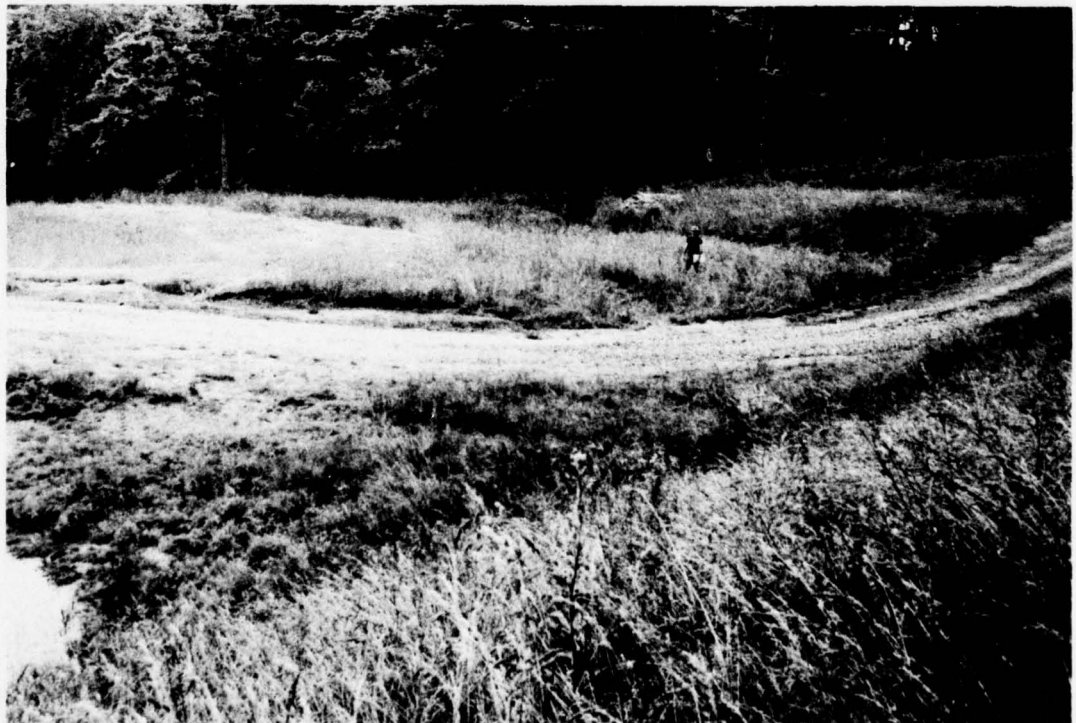
A small stream drains into the discharge channel of the emergency spillway and is depositing minor amounts of sediment at its outlet. Further downstream in the emergency spillway, the discharge channel has been badly eroded and a 3 feet deep gully has formed (see Plate 1). The runoff from the small stream appears to be the reason for the erosion.

PHOTO 4. Downstream View of Emergency Spillway Channel

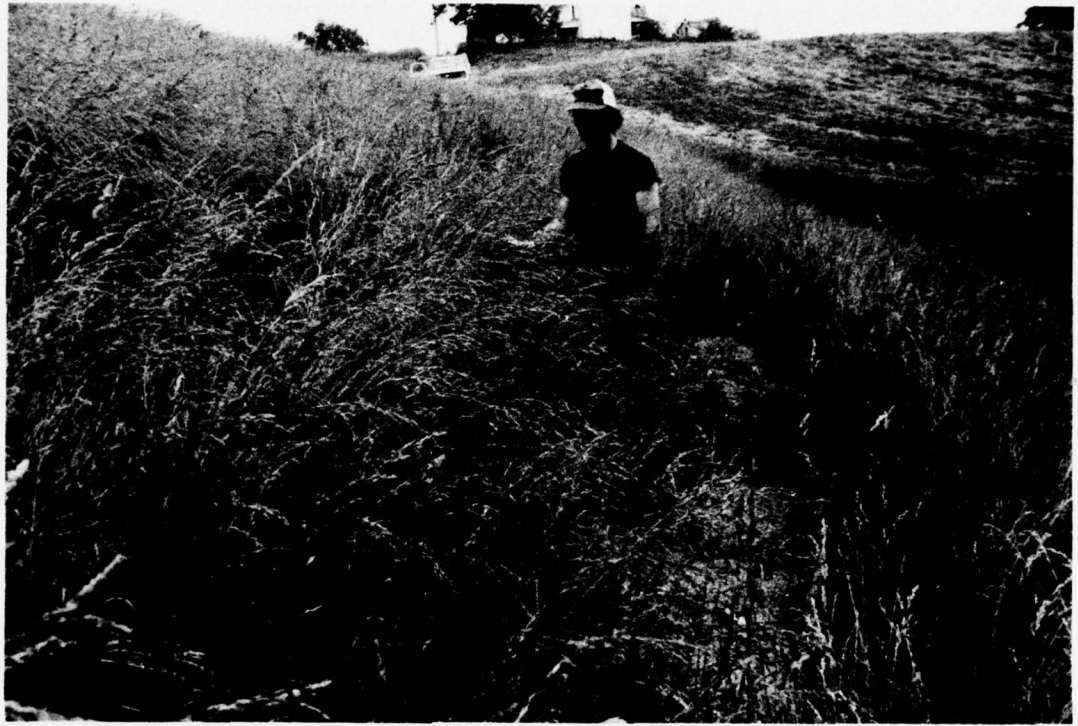
6.2.1 Visual Observations: Slumping has occurred on portions of the lower half of the downstream slope of the embankment (see Photo 5). The displacement is approximately 2 feet. The slumped areas are eroded and sparsely vegetated, but the silty and clayey soils are firm and no seepage was observed. The toe area of the dam is swampy, but a concentrated discharge was not detected.

The lower half of the downstream embankment has step-like slumps which should be corrected to prevent further deterioration. The exposed portion of the upstream embankment is eroding from wave action and will worsen if not corrected. With the exception of these deficiencies, the embankment is in satisfactory condition with no seepage observed during the field inspection.

PHOTO 5. Eroded Slump Scarps on the Downstream Embankment

It is recommended that the step-like slumps on the lower half of the downstream embankment be repaired as soon as possible. Proper drainage should also be provided by improving the outlet channel and swampy areas along the toe of dam. Riprap protection should be placed around the outlet pipe. The erosion along the upstream embankment at the waterline should be repaired and riprap should be placed to prevent future erosion. The erosion on the left abutment should be corrected by placing riprap on the eroded area. A well graded crushed stone would provide erosion protection for the road along the crest of the dam. A staff gage should be installed in the reservoir.
